SLOW SPEED CATCHES

Predictive Wins from Food & Beverage Facilities

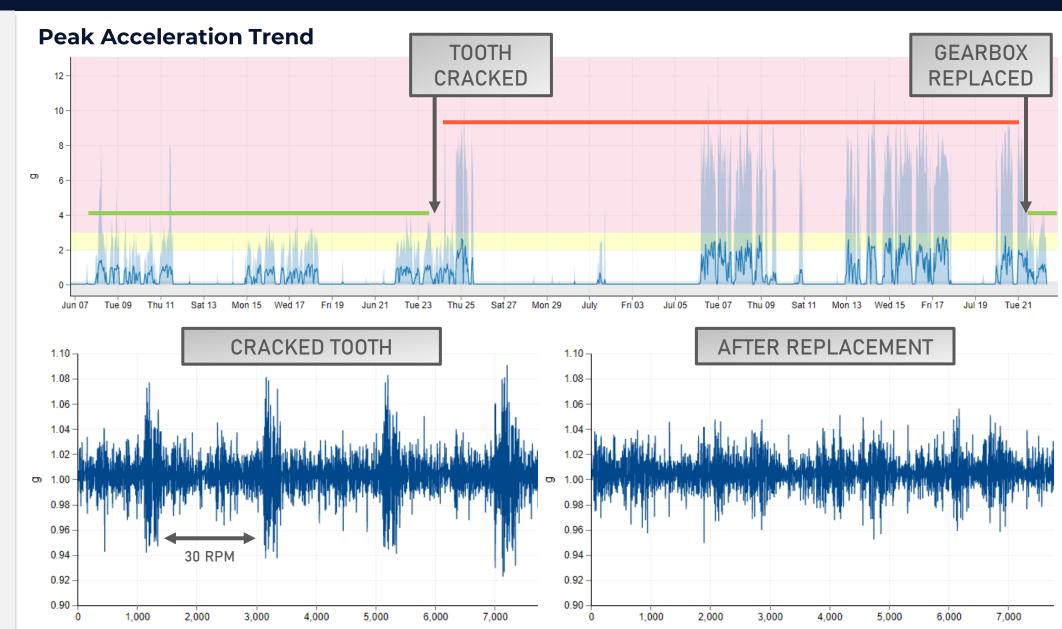
Cam Shaft Drive Gearbox

Specialty gearboxes are often custom designed, with long lead times. A worn gearset can interrupt operations for weeks at a time, with major financial implications.

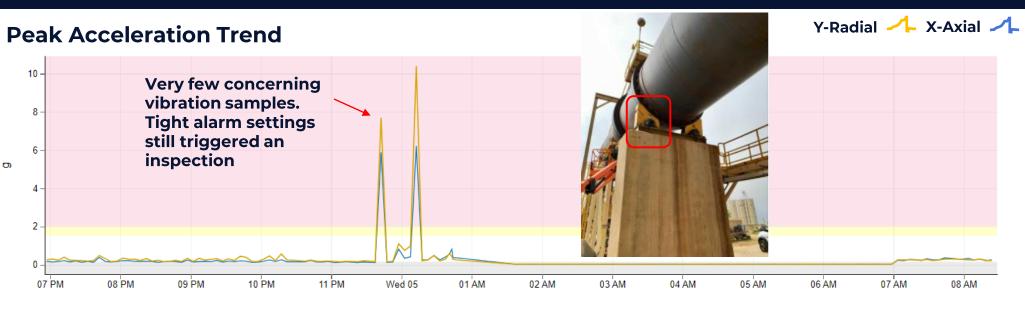
Temperature Comparison

Bearings are known to fail very quickly once damage occurs – matter of hours

Because this was known, very tight alarm settings were used. An inspection was recommended off only 2 high vibration samples

Comparing temperature to other bearings on the same dryer, bearing in question showed clear evidence that it was failing

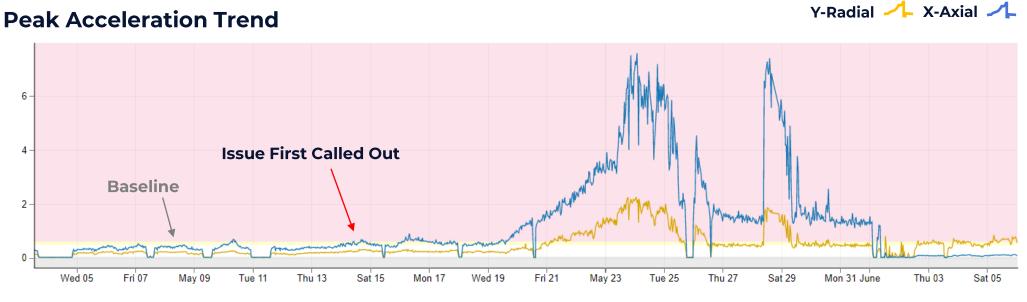
Frequency Spectrum

Collateral Damage if left unchecked:

Bearing fire

Complete belt failure

Structural damage

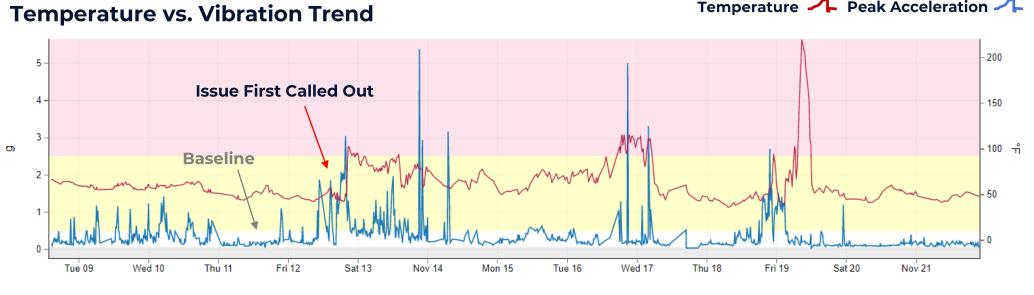
Bearing first called out for vibration increase

Field inspection found no issues, continued to operate as normal

Two weeks later, temperature spiked to over 225 F without much change in vibration

Root Cause:

Bearing had run out of grease. Bearing replaced
