SLOW SPEED CATCHES

Predictive Wins from Food & Beverage Facilities

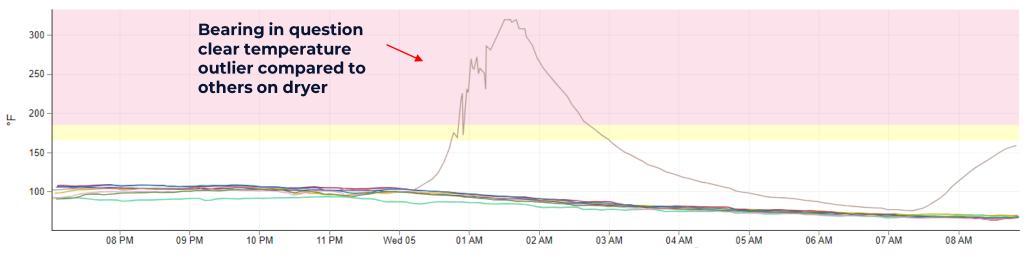
Temperature Comparison

Bearings are known to fail very quickly once damage occurs – matter of hours

Because this was known, very tight alarm settings were used. An inspection was recommended off only 2 high vibration samples

Comparing temperature to other bearings on the same dryer, bearing in question showed clear evidence that it was failing

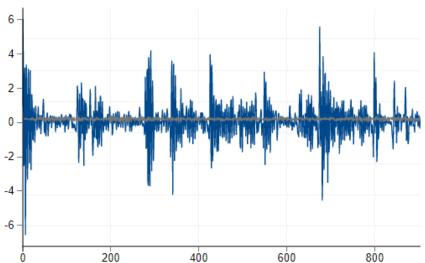
Belt Conveyor Bearing

Field inspection found no issues, continued to operate as normal

Root Cause:

Bearing had run out of grease. Bearing replaced
